US Army ManTechJournal

Corrosion Under Attack

Volume 10/Number 4/1985

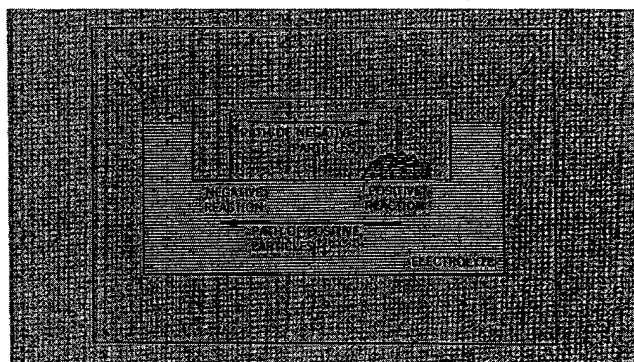
Figure 1

Rusting of iron and steel is caused by an electrochemical reaction. This reaction is divided into four parts or elements (Figure 1):

- A positive reaction
- A negative reaction
- A path for negative particles to flow
- A path for positive particles to flow.

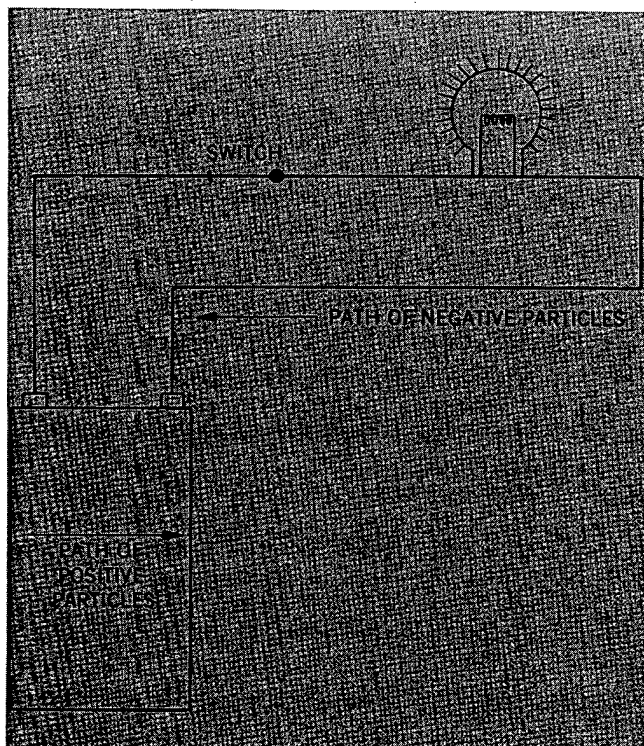
Figure 2

places of the same piece of metal. The negative particles either flow through the joint between the two metals or through the metal itself. The final, crucial element in the corrosion reaction is the path for the positive particles (the electrolyte). This electrolyte most often is water or salt water (Figure 3).

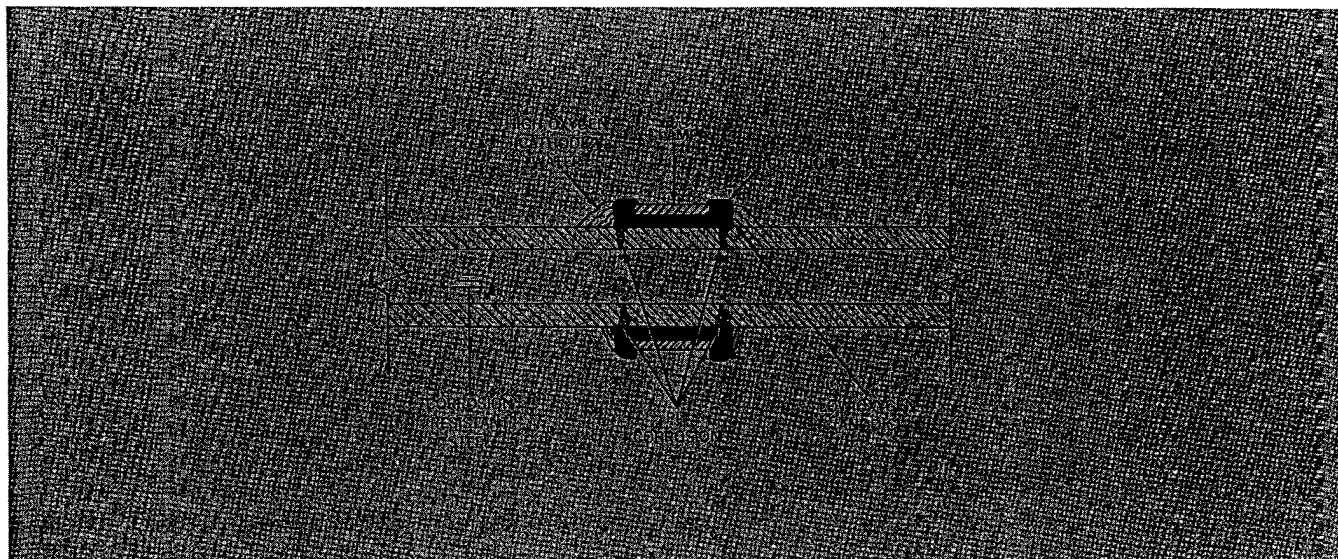
Figure 15 shows how these clamps can accelerate corrosion:

Corrosion is accelerated in areas where there is a differential in the amount of oxygen present. In Figure 15, it can be seen that the cushion seal results in a low oxygen area, while the line itself is in a high oxygen area. This differential, with water as an electrolyte, results in a rapid pit corrosion and line failure. Process these areas thoroughly.

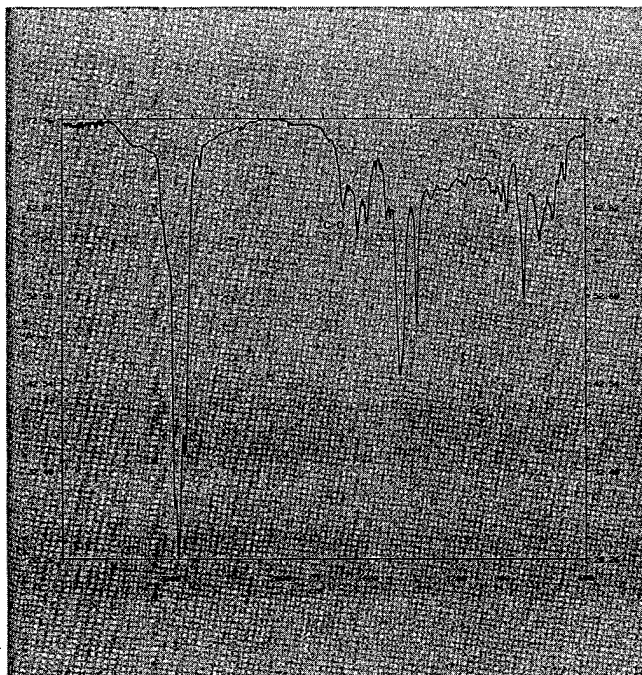
Each residue was then redissolved in methylene chloride. A film was deposited on a potassium bromide salt crystal. An infrared spectrum was taken from 4000 cm^{-1} to 600 cm^{-1} (Figures 1-3).

Figure 1. Infrared Spectrum of Methylene Chloride Extract of Relatively New Mask, Sample #1

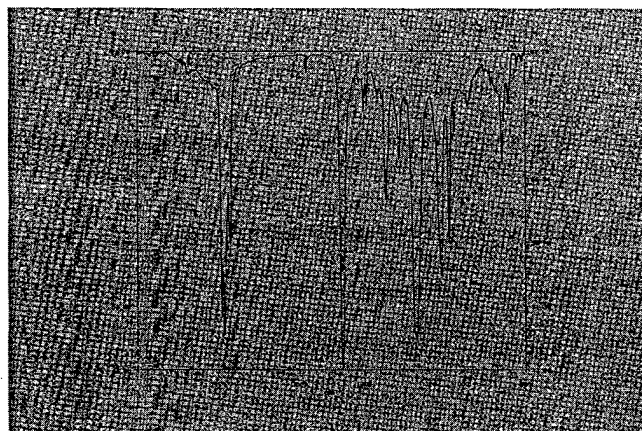
Figure 2. Infrared Spectrum of Methylene Chloride Extract of Gas Mask, Sample #2

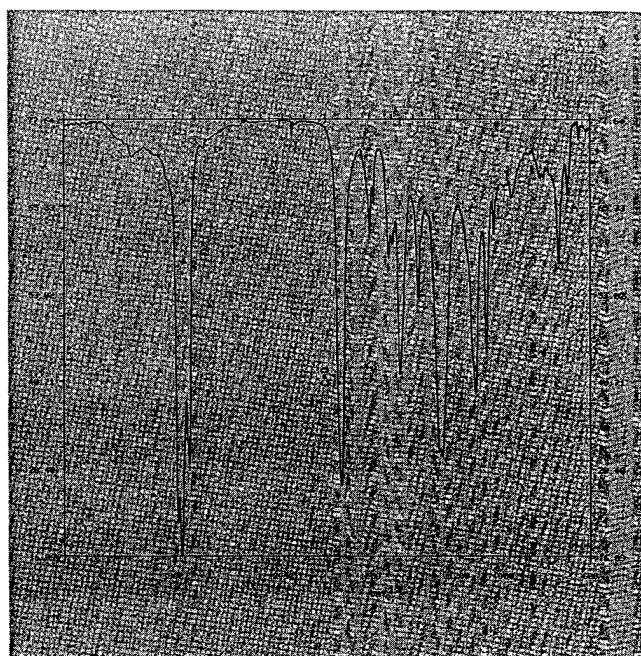
Figure 3. Infrared Spectrum of Methylene Chloride Extract of Dry Rot Throughout Entire Mask, Sample #3

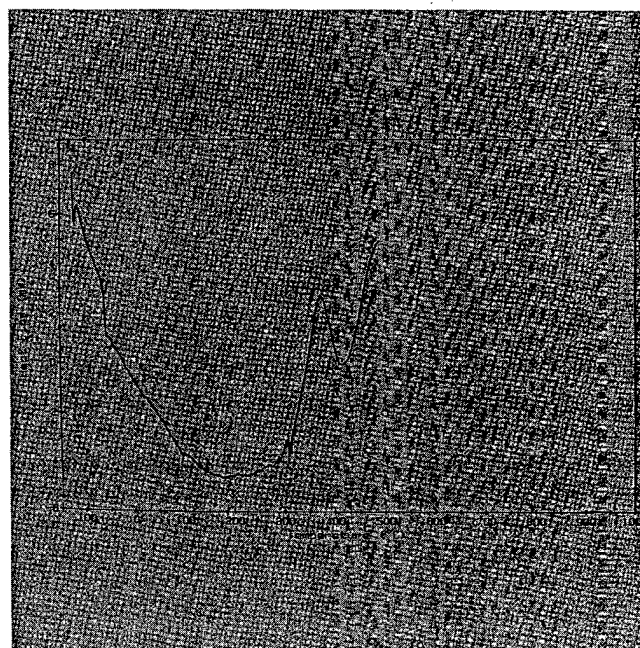
- **Differential Scanning Calorimetry Analysis (DSC), Thermogravimetric Analysis (TGA) and Thermo-mechanical Analysis (TMA).** The thermal analysis measurements were made on a Dupont 1090 thermal analyzer system utilizing a 910 DSC cell, a 951 thermogravimetric analyzer, and a 941 thermo-mechanical analyzer. Copies of the DSC scans are included with the experimental conditions listed on each scan (Figures 4-6).

Figure 4. DSC Scan of Relatively New Mask, Sample #1

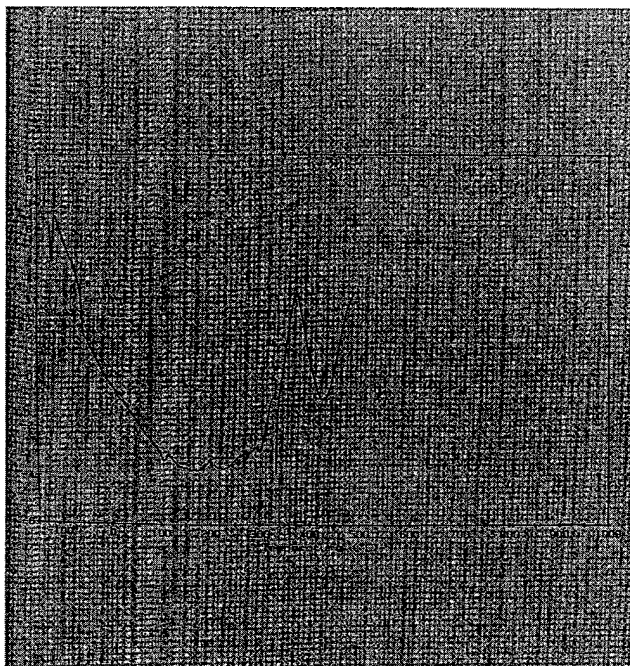
Figure 5. DSC Scan of Gas Mask, Sample #2

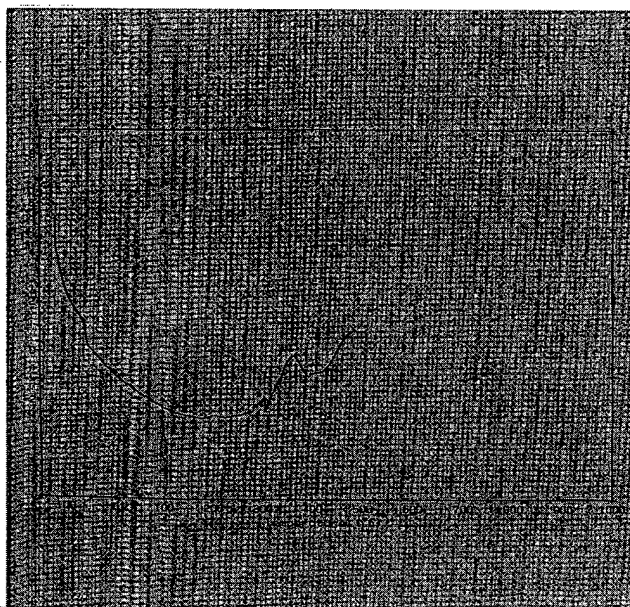
Figure 6. DSC Scan of Dry Rot Throughout Entire Mask, Sample #3

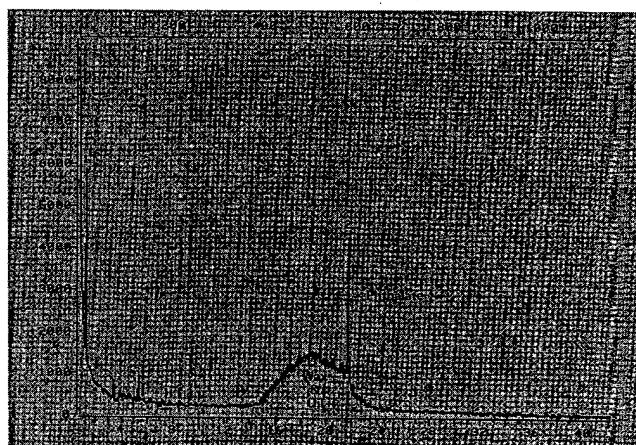
interfaced to a 1000 data systems. A 12 meter fused silica capillary column of cross-linked methyl silicone (SE-30) was programmed from 50 C to 260 C at 10 C/min. A mass range of 33-450 amu was repeatedly scanned at 2.5 second intervals. The chromatographic effluent was subjected to electron ionization spectrometry analysis at 70eV at 5×10^{-5} torr. Spectra derived from each analysis were compared to a computerized reference spectra contained in the Wiley-NBS data base. The pyrograms are shown in Figures 7-9.

Figure 7. Gas Mass Chromatogram of Relatively New Mask, Sample #1

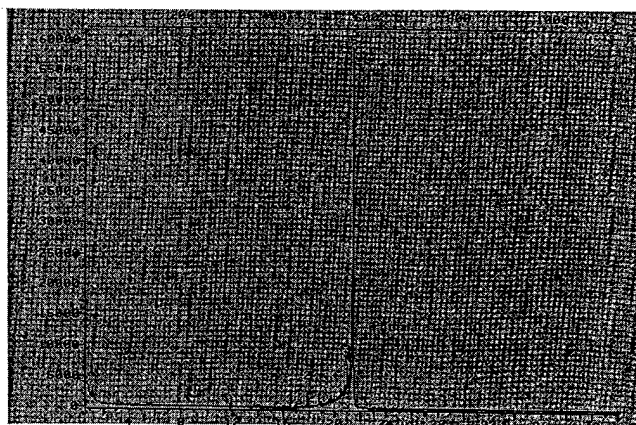
Figure 8. Gas Mass Chromatogram of Gas Mask, Sample #2

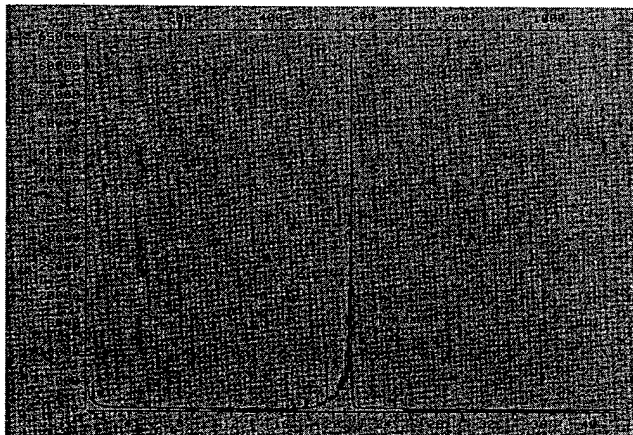
Figure 9. Gas Mass Chromatogram of Dry Rot Throughout Entire Mask, Sample #3

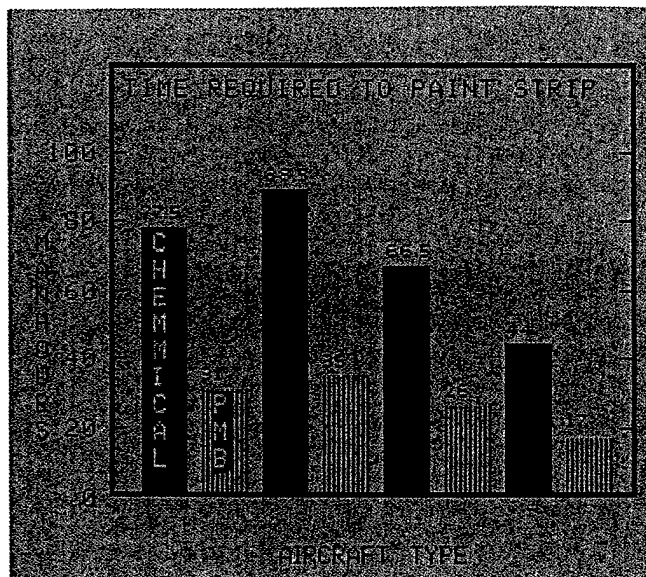
Figure 1 shows the relative times required to strip four different Army helicopters by Plastic Media Blast and by chemical means. Figure 2 shows the first rotary wing aircraft PMB stripped. The time required was 12 hours, compared to 32 hours by chemical strip. The effectiveness of PMB on fiberglass airframe components is seen in Figure 3, a closeup of the nose of the helicopter.

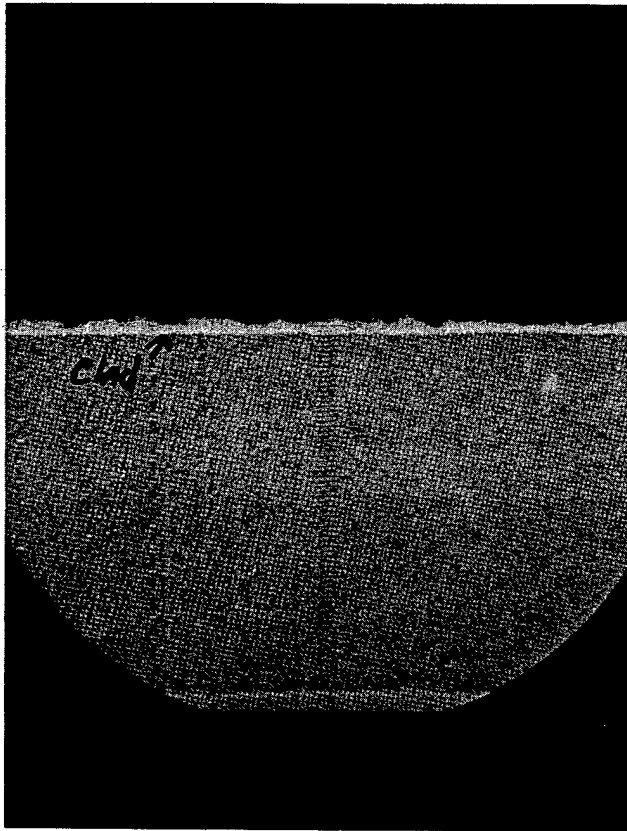
Figures 4, 5, and 6 illustrate how the lack of damage to aircraft surfaces can extend the life of that aircraft. Figure 4 shows a helicopter tailboom which was primed, painted, and Plastic Media Blasted five times. Figure 5 is a closeup of the skin section of this tailboom. The darkened, smudged areas are residual primer still attached to the skin. It is not necessary to remove all of the primer down to white metal if MIL-P-23377 epoxy primer is used. Figure 6 is a photomicrograph of a skin section from this tailboom. The average clad thickness of the

blasted side is 0.0015 inch, compared to a thickness of 0.0022 inch for the unblasted side. With five years between strip and paint cycles, this photomicrograph represents a life span of 25 years on the skin.

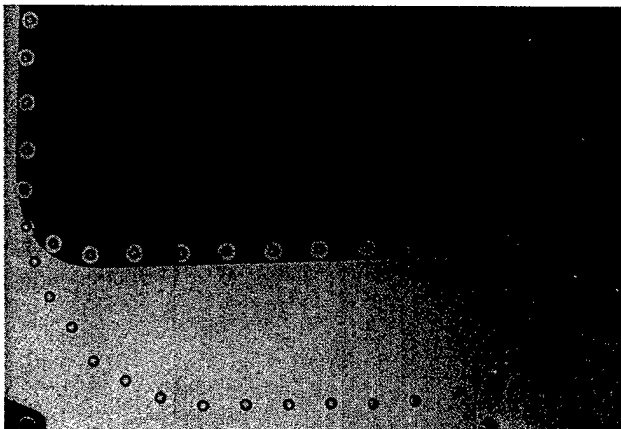
Figure 11

Another special benefit from PBM is seen in Figure 11, which illustrates how effective the technique is for removing finishes from rivets and screws without damaging the skin surfaces or the fasteners themselves and the joint itself.

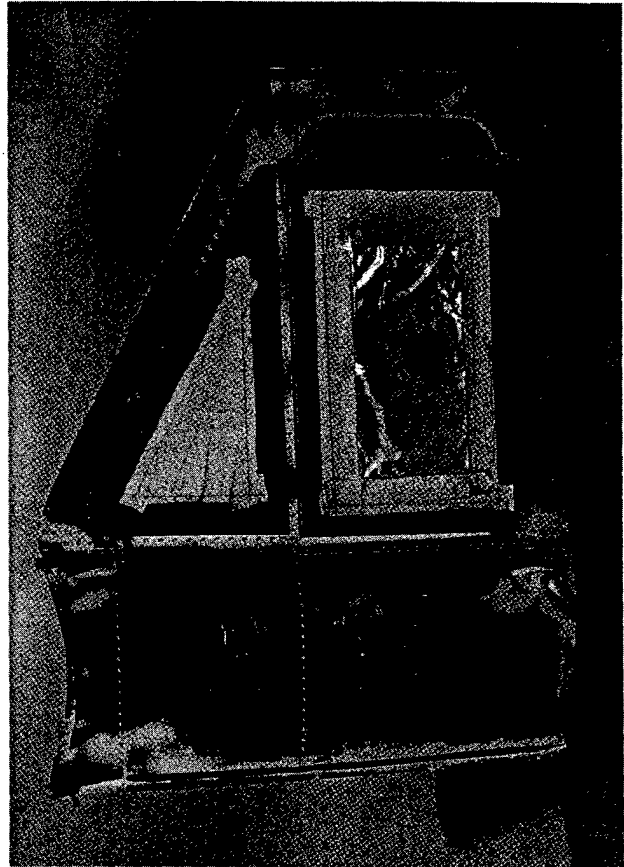
Figure 12 illustrates another unique advantage of using Plastic Media Blast stripping. It shows a helicopter door after selective stripping using low pressure and small media, with only the top coat of paint removed.
